8.

TIMBER CONSERVATION

THE AGA KHAN TRUST FOR CULTURE

This section provides guidelines on recommended procedures of repair and maintenance of both structural and non-structural timber elements.

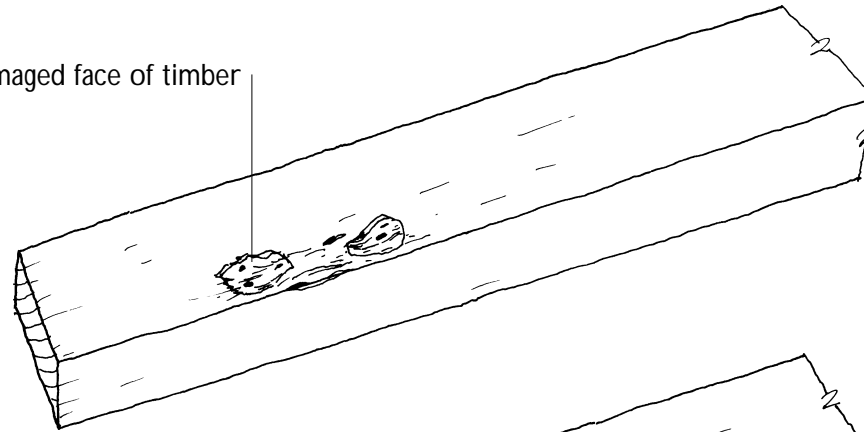
PLUG REPAIR

damaged face of timber

alternative plug shape

Note: the grain of the timber of the plug must run in the same direction as the surrounding timber, and the moisture content and species must be the same as the piece being repaired.

1. Cut rebate with a chisel. The plug should be proud of the surrounding timber.
2. Glue and plain to finish.

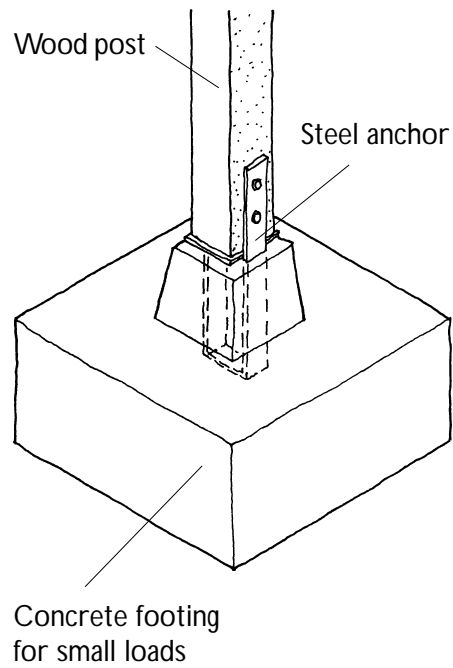
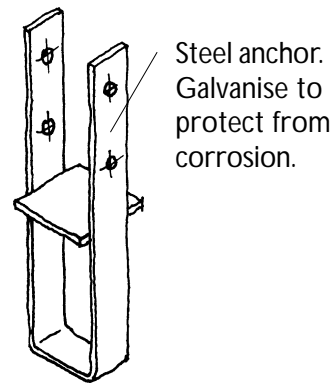
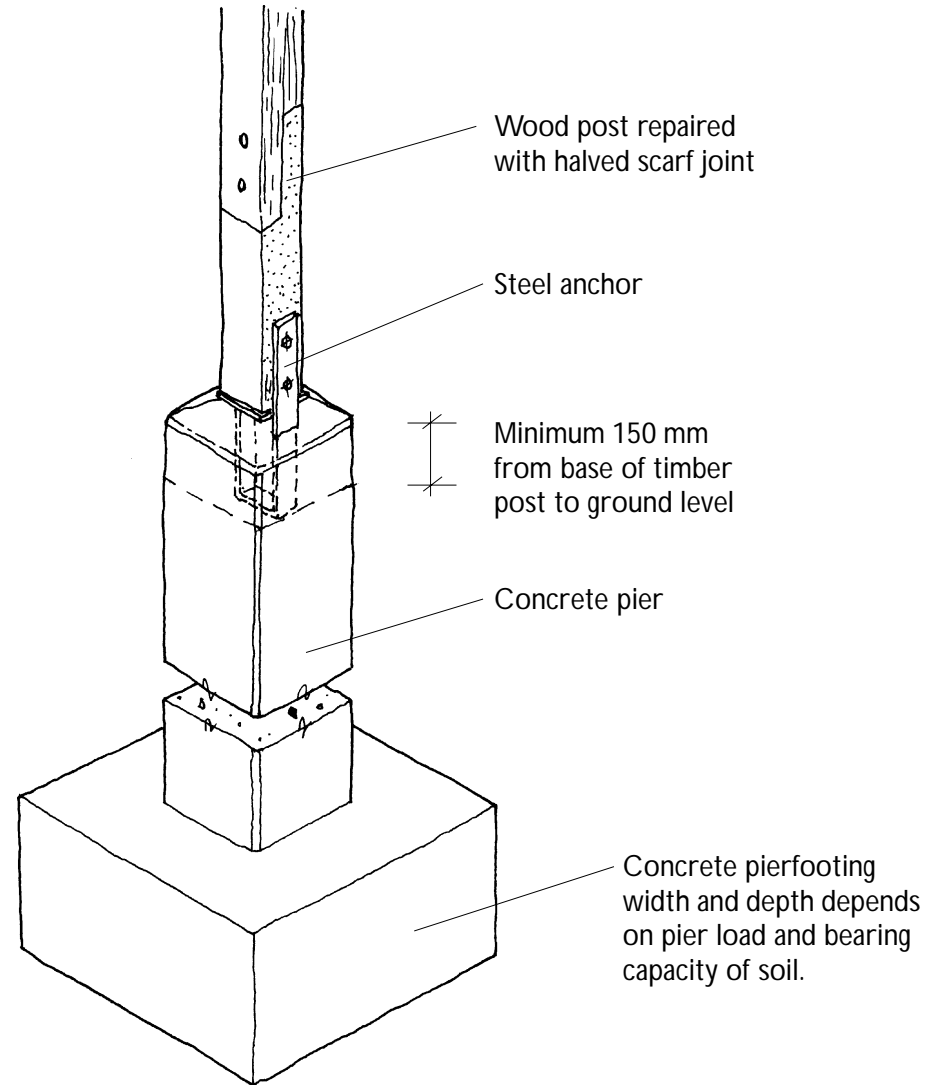
Detail 5

BASE OF TIMBER POST

Posts set in the ground
Check for decay. Ensure the base is clear of debris and check timber in the base, frequently very vulnerable, and replace bottom part if required.
